Using High Energy Computed Tomography (CT) to Aid Design Engineering in Optimizing Combustion Turbine Airfoil, Cooling Performance

Kevin Bailey – Siemens
Thomas Quinn – Siemens
11842 Corporate Blvd
Orlando, FL 32817

Robert Maziuk – VJ Technologies
80 Commerce Street
East Haven, CT 06512

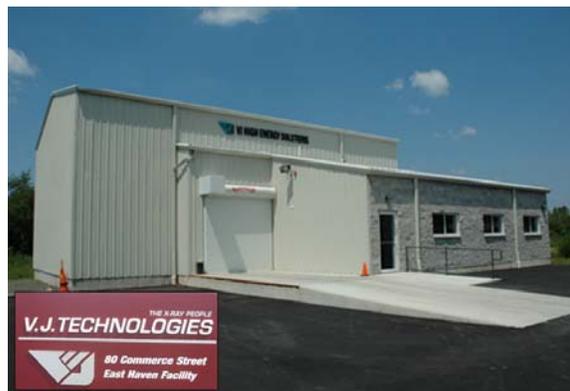
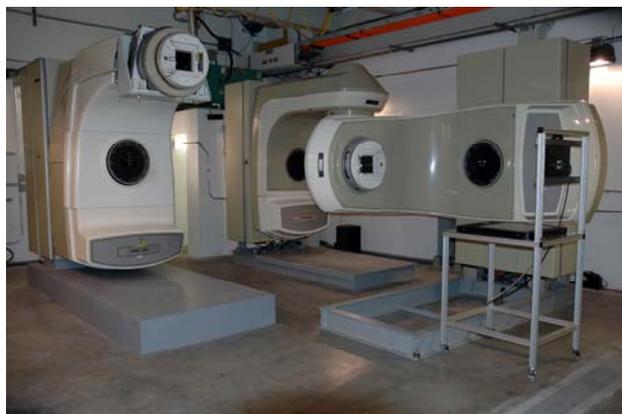
Figure 1

Based on their high energy (6MEV) facility (Figure 1 and 2), VJ Technology was selected by Siemens to develop a CT process for scanning these parts. Preliminary CT scans demonstrated a reliable means of accurately
